**Flood Control Project Maintenance
Levee Inspections**

Fall 2018 Levee Maintenance Deficiency Summary Report

**Flood Control Project Maintenance
Levee Inspections****LMA District Cover Sheet
Fall 2018 Levee Inspection Results****Sacramento River West Side Levee District**

Sacramento River West Side Levee District

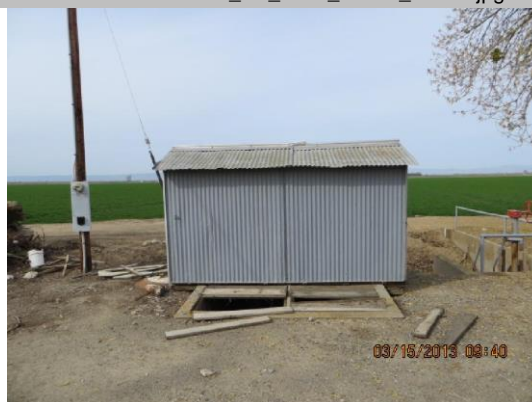
Photo 2 of 3 : UCIP_FA_2018_10306_17565.jpg

Pumphouse and sump on LS toe.

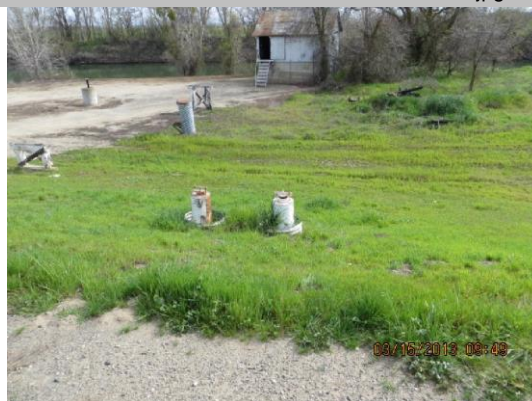
Photo 3 of 3 : UCIP_FA_2018_10306_17564.jpg

siphon breakers in CMP risers on WS slope.

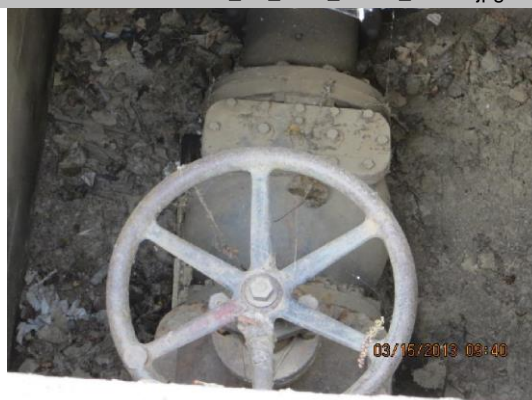
Photo 2 of 3 : UCIP_FA_2018_10307_17568.jpg

Slide gate in concrete vault under pumphouse at LS toe.

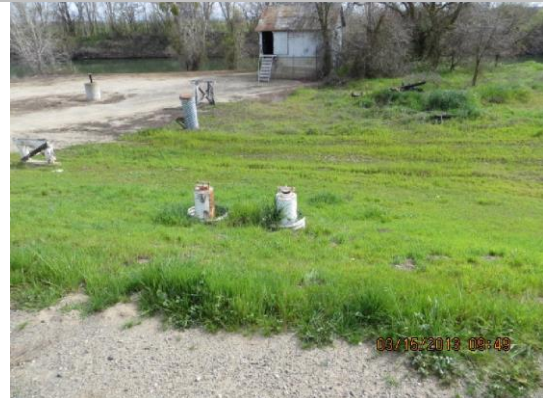
Photo 3 of 3 : UCIP_FA_2018_10307_17567.jpg

Siphon breaker in 24-inch CMP riser on WS slope.

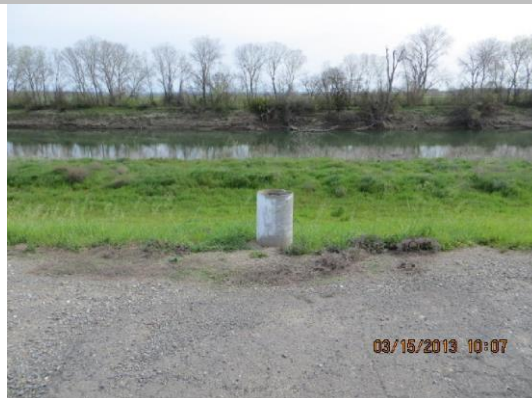
Photo 1 of 3 : UCIP_FA_2018_53019_17587.jpg

Comment Code						
Inspector Comment						
FS_ID:53019 DS_ID:20311 EP_NO: 12609 Repair Type: Urgent Crossing Status: Found UCIP Comments: 10/16/2018 Water level is low enough to see that flap gate on WS end is missing. In addition, pipe has corroded through around flap gate frame. Unable to locate pipe inlet on LS. Crossing must be abandoned properly. Recommend internal pipe inspection to determine pipe integrity through levee. (O.Yakimov - DWR)09/23/2016 - pipe outlet still submerged, but visible enough to determine that flap gate is still missing. Appurtenances on the LS of the levee do not appear to be associated with this pipe. There is no visible location for collection of drainage water to go through the outfall. As a result, it does not appear that this pipe is in use. (T. Hatch/UCIP) 09/01/201 - pipe outlet was submerged at time of inspection. Unable to view if flap gate had been replaced. Otherwise, conditions do not appear to be significantly different from previous inspection. (T. Hatch/UCIP) 03/15/201- Flap gate missing from waterward end of pipe. (W. Wylie/UCIP) FIELD_STRUCT_DESC: 24-inch steel outfall drainage pipe through the levee, 4.1 feet below the crown. Siphon breaker inside an 18-inch concrete riser unit on the waterside (WS) shoulder. Flap gate on the WS toe. Rock protection along the riverbank at the WS toe. (Permit No. 12609, 1978 - Jack E. Gross). [Additional Reference(s): DWR Levee Log, 2006]. FS Date: 10/16/2018 7:37:46 AM

18-inch concrete riser on WS shoulder.

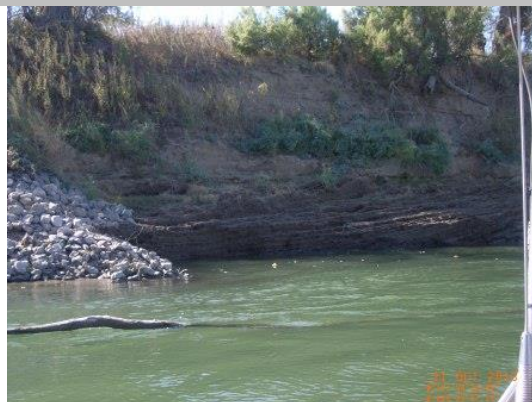
Photo 1 of 1 : FA_2018_NA0016_435_91_20181023_00234.jpg

LM Start	29.96	Rating **	M	Issue No.	91
LM End	30.12	Issue Type +	Ma	Location *	WS
Category	Supplemental			GPS Latitude/Longitude	
				Start	End
Item	2017 USACE Erosion Survey, DRAFT			39.065886 °	39.067386 °
				-121.842950 °	-121.845266 °
DWR ID	DWR_NA0016_01_f_2018_91

Comment Code					
Inspector Comment					
2017 Site ID: SAC 122.3 R					
Status: Eroding					
2017 Field Notes: Fresh slumping erosion at toe.					
Site History: 2002 - Upstream end has recent slope failure and exposure of tree roots. 2003 - Some new minor slope erosion with new snags on the bank. 2004 - Appears a little worse. 2005 - Scallop in bank at the upstream end looks worse. 2009 - Minimal new erosion, Berm width is still large, but one large event or one fallen tree and it could go fast. 2010 - New erosion, bank is nearly all vertical from slumping. Site looks bad. 2011 - Site continues to look bad. 2012 - Minor new erosion. 2015 - Undermining of toe rock. 2016 - Site extended upstream, new erosion and exposed tree roots.					
DWR Inspector Comment: No erosion within the prism and vegetation appears to be stabilizing the bank. Recommend monitoring.

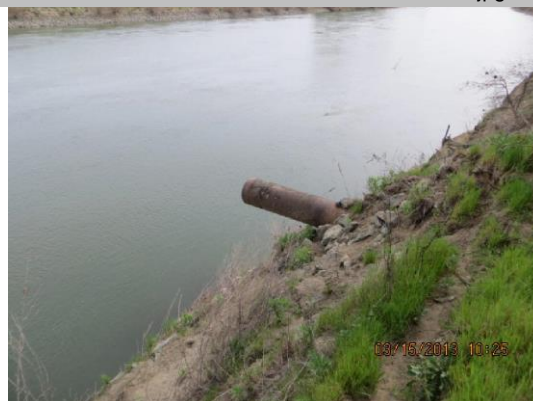
Photo 1 of 3 : UCIP_FA_2018_10325_17591.jpg

Comment Code						
Inspector Comment						
FS_ID:10325 DS_ID:20317 EP_NO: 14495 Repair Type: Non-Urgent Crossing Status: Found UCIP Comments: Pipe may need flap gate at water side. FIELD_STRUCT_DESC: 22-inch steel drainage pipe through the levee, 3.8 feet below the crown. Pipe extends from existing pump house located at the landside (LS) toe through the levee to the low-water channel. Siphon breaker in 24-inch corrugated metal riser unit on LS shoulder. (22-inch pipe authorized under Permit No. 14495, 1986 - Jack Gross; 22-inch pipe replaced previous 12-inch and 16-inch pipes, installed under Automatic Board Order (ABO) issued as Permit No. 9358, 1974 - Crocker National Bank (Trustee)). FS Date: 3/15/2013

24-inch pipe at rivers edge

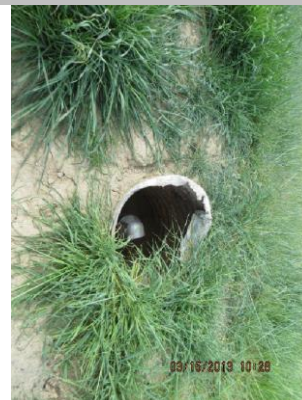
Photo 2 of 3 : UCIP_FA_2018_10325_17590.jpg

Siphon breaker in 24-inch cmp on LS shoulder.

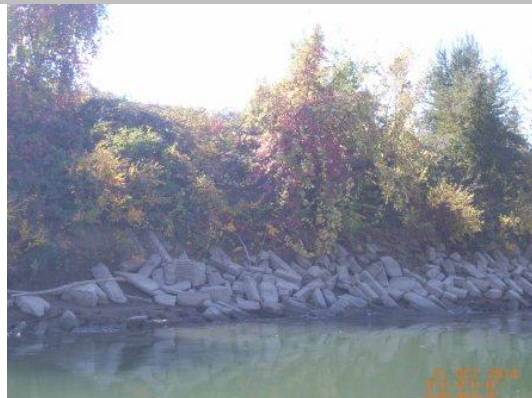
Photo 1 of 1 : FA_2018_NA0016_435_92_20181023_00235.jpg

LM Start	31.43	Rating **	A/W	Issue No.	92
LM End	31.45	Issue Type +	Ma	Location *	WS
Category	Supplemental			GPS Latitude/Longitude	
				Start	End
Item	2017 USACE Erosion Survey, DRAFT			39.067004 °	39.066901 °
				-121.866913 °	-121.867322 °
DWR ID	DWR_NA0016_01_f_2018_92				
Comment Code					
Inspector Comment					
2017 Site ID: SAC 123.7 R Status: Eroding 2017 Field Notes: No observed change. Site History: 1997 - Erosion into the levee section; old concrete rubble loss at toe; transition between the rock upstream and the cobble downstream. 2000 - Cohesive bench with concrete slabs on top; 25 ft deep scour hole on the downstream end.					
DWR Inspector Comment: Appears to be stable. Plenty of berm and cobble left.

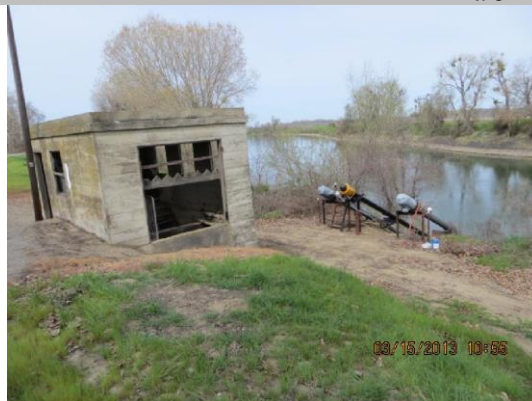
Photo 1 of 3 : UCIP_FA_2018_11543_18942.jpg

Comment Code					
Inspector Comment					
FS_ID:11543 DS_ID:20262 EP_NO: 9338 Repair Type: Non-Urgent Crossing Status: Found UCIP Comments: Pipe leaking at intake pipe on rivers edge below pump FIELD_STRUCT_DESC: 24-inch steel irrigation pipe through the levee, 24 feet below the crown. Slide gate in abandoned concrete pump house on the waterside (WS) slope. Three slant pumps mounted on a pile structure on the WS bank. 30-inch concrete pipe under the highway on the landside (LS). 48-inch steel riser unit on the LS of the highway. Overhead high tower power line crosses the levee. Power line has been run underground to service box on WS shoulder at LM 32.01. Ramps on both slopes. (Automatic Board Order (ABO) issued as Permit No. 9338, 1974 - Julie Ann Steidlmayer). [Additional Reference(s): DWR Levee Log, 2006. USACE Sacramento O&M Manual 131, May 1960 (HLM 32.02)]. FS Date: 3/15/2013

Concrete block house with slide gate inside.

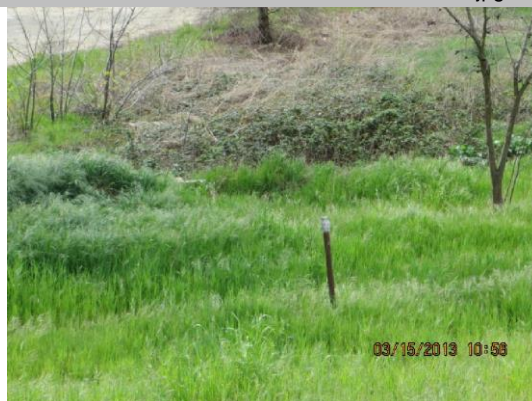
Photo 2 of 3 : UCIP_FA_2018_11543_18941.jpg

Siphon breaker on LS toe.

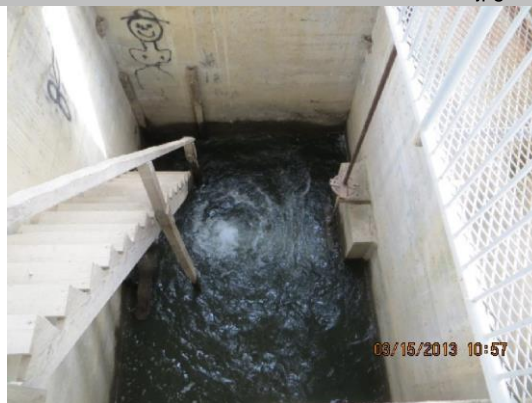
Photo 3 of 3 : UCIP_FA_2018_11543_18940.jpg

Slide gate inside concrete block house.

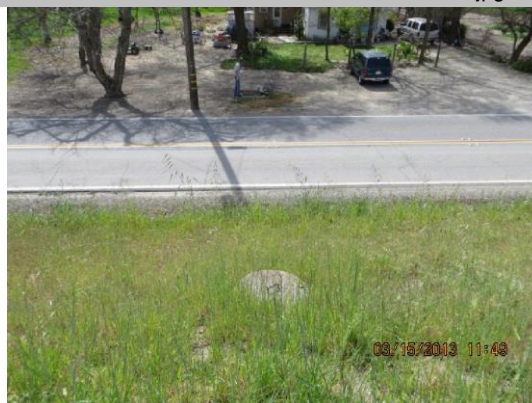
Photo 1 of 2 : UCIP_FA_2018_10364_17645.jpg

Comment Code						
Inspector Comment						
FS_ID:10364						
DS_ID:20304						
EP_NO: 9374						
Repair Type: Non-Urgent						
Crossing Status: Found						
UCIP Comments: Need to verify type of abandonment						
FIELD_STRUCT_DESC: *ABANDONED* 2 of 4: 4-inch irrigation pipe of an unknown material through the levee, 6.5 feet below the crown. Gate valve on the waterside (WS) end. Siphon breaker inside a 24-inch corrugated metal riser unit on the landside (LS) slope. 4-foot by 4-foot concrete distribution box on the south side of Highway 45 at the LS toe. (Automatic Board Order (ABO) issued as Permit No. 9374, 1974 - Richard H. Moore). [Additional Reference(s): DWR Levee Log, 1980. USACE Sacramento O&M Manual 131, May 1960 (HLM 32.68)].						
FS Date: 3/15/2013

Siphon Breaker in 25-inch CMP riser on LS slope with 4X4 concrete box off LS toe.

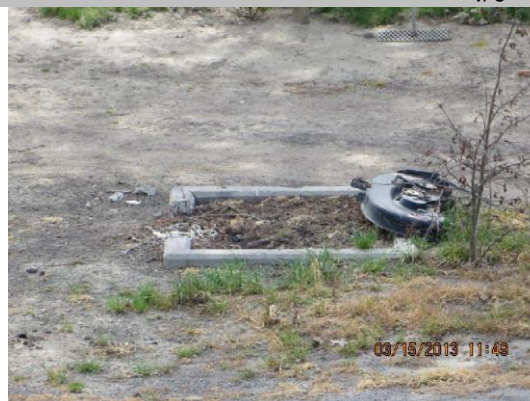
Photo 2 of 2 : UCIP_FA_2018_10364_17644.jpg

4X4 concrete box off LS toe.

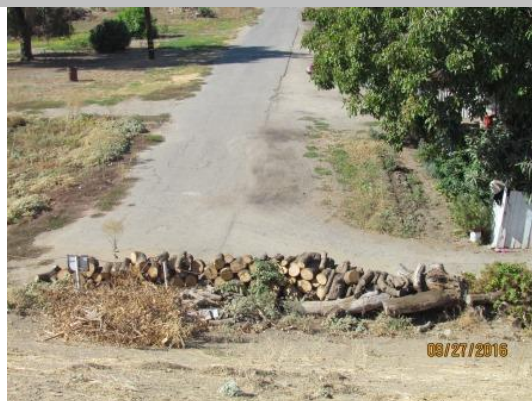
Photo 1 of 1 : FA_2018_NA0016_435_87_20180904_00020.jpg

LM Start	32.95	Rating **	M	Issue No.	87
LM End	32.95	Issue Type +	En	Location *	LS
Category	Earthen Levee			GPS Latitude/Longitude	
				Start	End
Item	Encroachments			39.074125 °	39.074125 °
				-121.891836 °	-121.891836 °
DWR ID	DWR_NA0016_01_f_2016_87				
Comment Code					
FW : Firewood					
Inspector Comment

Firewood within 10 feet of levee toe on landside. Fall 2016 inspection.

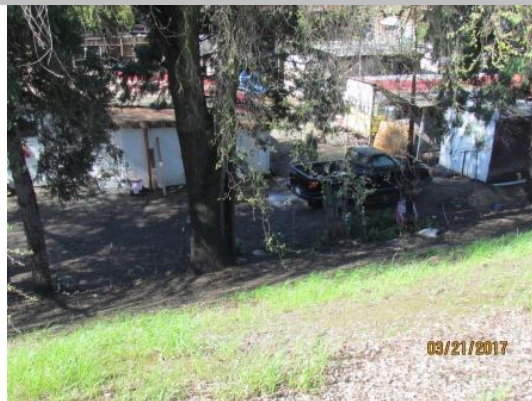
Photo 1 of 1 : FA_2018_NA0016_435_43_20180904_00015.jpg

LM Start	32.97	Rating **	M	Issue No.	43
LM End	32.97	Issue Type +	En	Location *	LS
Category	Earthen Levee			GPS Latitude/Longitude	
				Start	End
Item	Encroachments			39.074346 °	39.074346 °
				-121.892048 °	-121.892048 °
DWR ID	DWR_NA0016_01_s_2012_43				
Comment Code					
FE : Fence					
Inspector Comment					
Fence blocking access on landside toe.

Fence blocking access along landside levee toe. Spring 2017.

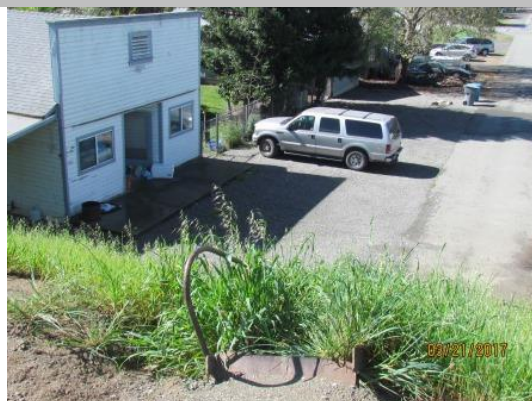
Photo 1 of 1 : FA_2018_NA0016_435_157_20180904_00048.jpg

LM Start	33.03	Rating **	A/W	Issue No.	157
LM End	33.03	Issue Type +	En	Location *	LS
Category	Earthen Levee			GPS Latitude/Longitude	
				Start	End
Item	Encroachments			39.075015 °	39.075015 °
				-121.892705 °	-121.892705 °
DWR ID	DWR_NA0016_01_s_2017_157				
Comment Code					
ST : Stairway					
Inspector Comment					
Permit No. 9331.

Permanent metal staircase installed on landside levee slope. Spring 2017.

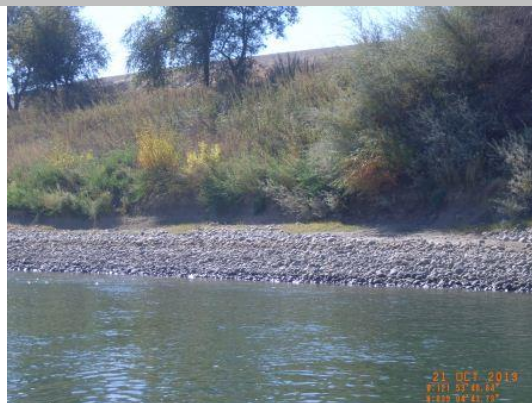
Photo 1 of 1 : FA_2018_NA0016_435_93_20181023_00236.jpg

LM Start	33.29	Rating **	A/W	Issue No.	93
LM End	33.37	Issue Type +	Ma	Location *	WS
Category	Supplemental			GPS Latitude/Longitude	
				Start	End
Item	2017 USACE Erosion Survey, DRAFT			39.078340 °	39.079351 °
				-121.894656 °	-121.895317 °
DWR ID	DWR_NA0016_01_f_2018_93				
Comment Code					
Inspector Comment					
2017 Site ID: SAC 125.6 R					
Status: Eroding					
2017 Field Notes: No observed change.					
Site History: 2008 - Slow erosion of the hard toe. 2010 - Cobble rubble is failing, erosion is into the toe of the levee, with vertical slumping.					
2012 - Site appears to be relatively stable. 2013 - New animal holes.

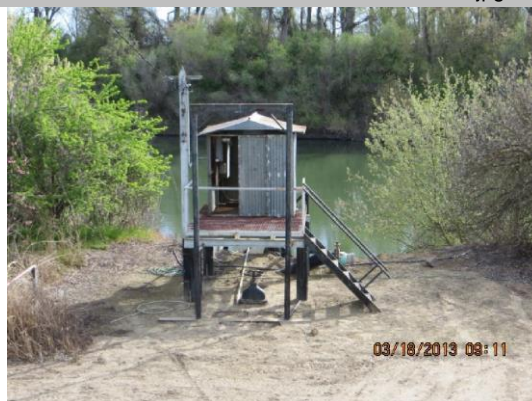
Photo 1 of 3 : UCIP_FA_2018_10403_17662.jpg

Comment Code						
Inspector Comment						
FS_ID:10403 DS_ID:20268 EP_NO: 9364A Repair Type: Non-Urgent Crossing Status: Found UCIP Comments: Pipe rusted through at concrete distribution box. May be indicator of pipe condition through levee. FIELD_STRUCT_DESC: 1 of 4: 16-inch steel irrigation pipe through the levee, 6.3 feet below the crown. Pump in pump house on the waterside (WS) end. Siphon breaker in a 36-inch steel riser unit on the landside (LS) slope. Discharges into a 5-foot by 9-foot concrete distribution box at the LS toe. (Automatic Board Order (ABO) issued as Permit No. 9364-A, 1974 - Alice Steidlmayer). (Installed by the United States Army Corp of Engineers, 1945). [Additional Reference(s): DWR Levee Log, 2006. USACE Sacramento O&M Manual 131, May 1960 (HLM 34.46)]. FS Date: 3/18/2013

Pump at WS berm.

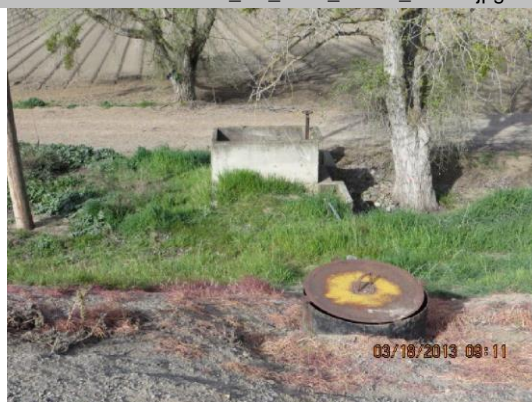
Photo 2 of 3 : UCIP_FA_2018_10403_17661.jpg

siphon breaker in 36-inch steel riser on LS slope with concrete distribution box on LS toe.

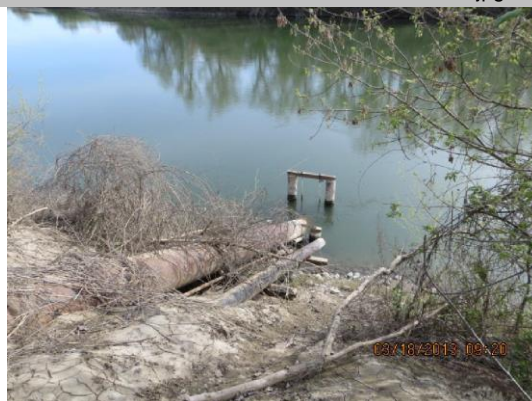
Photo 3 of 3 : UCIP_FA_2018_10403_17660.jpg

Item	DWR UCIP Field Study			39.087072°	39.087072°	
				-121.896464°	-121.896464°	
DWR ID	20268					
Comment Code						
Inspector Comment						
FS_ID:10403 DS_ID:20268 EP_NO: 9364A Repair Type: Non-Urgent Crossing Status: Found UCIP Comments: Pipe rusted through at concrete distribution box. May be indicator of pipe condition through levee. FIELD_STRUCT_DESC: 1 of 4: 16-inch steel irrigation pipe through the levee, 6.3 feet below the crown. Pump in pump house on the waterside (WS) end. Siphon breaker in a 36-inch steel riser unit on the landside (LS) slope. Discharges into a 5-foot by 9-foot concrete distribution box at the LS toe. (Automatic Board Order (ABO) issued as Permit No. 9364-A, 1974 - Alice Steidlmayer). (Installed by the United States Army Corp of Engineers, 1945). [Additional Reference(s): DWR Levee Log, 2006. USACE Sacramento O&M Manual 131, May 1960 (HLM 34.46)]. FS Date: 3/18/2013

Pipe at waters edge.

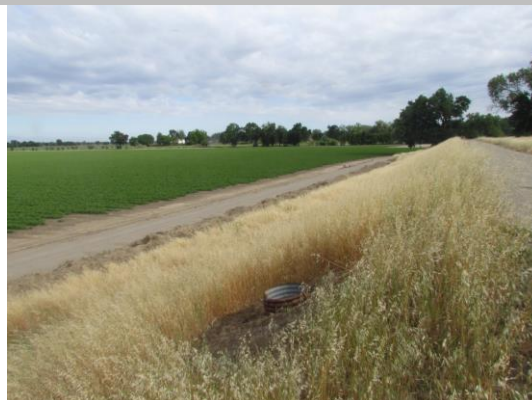
Photo 1 of 1 : FA_2018_NA0016_435_100_20180904_00024.jpg

LM Start	34.01	Rating **	M	Issue No.	100
LM End	34.07	Issue Type +	En	Location *	LS
Category	Earthen Levee			GPS Latitude/Longitude	
				Start	End
Item	Encroachments			39.087176 °	39.088099 °
				-121.896480 °	-121.896498 °
DWR ID	DWR_NA0016_01_f_2018_100				
Comment Code					
DT : Ditch					
Inspector Comment

View of the ditch at the landward side of the levee looking upstream. Spring 2015.

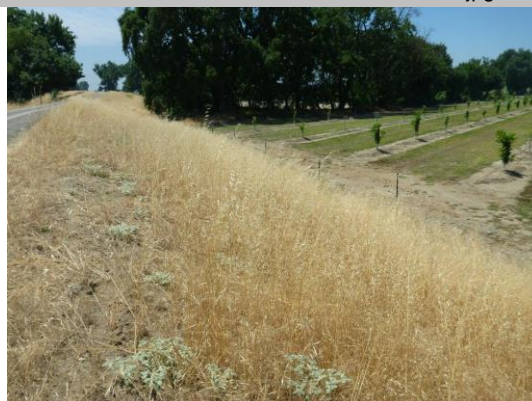
LM Start	34.24	Rating **	A/W	Issue No.	123
LM End	34.56	Issue Type +	Ob	Location *	
Category	Supplemental			GPS Latitude/Longitude	
				Start	End
Item	2017 Storm Damage			39.090511 °	39.094967 °
				-121.895675 °	-121.894858 °
DWR ID	DWR_NA0016_01_f_2017_123				
Comment Code					
Inspector Comment					
Levee Evaluation Comments					
Description:					
Site ID No:185					
Site Designation:SRWLD-03					
Repair Type: Seepage					
Rating:Critical					
Field Date:7/14/2017					
Notes: Well water tank 10' from LS toe & wire fence at LS toe					
Currently taking core samples.

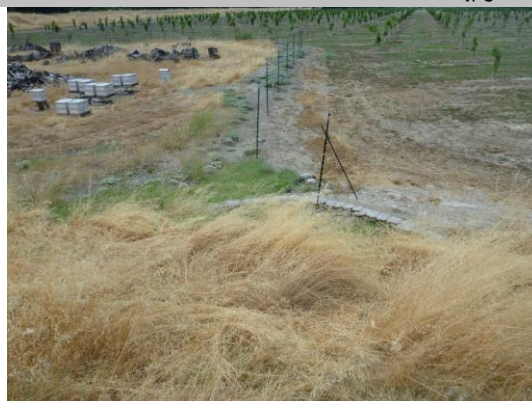
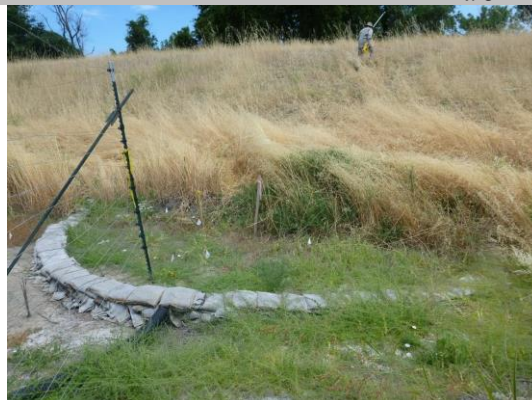
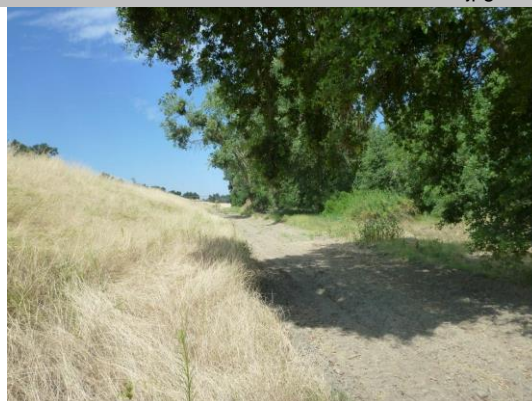
LM Start	34.65	Rating **	A/W	Issue No.	125
LM End	34.72	Issue Type +	Ob	Location *	
Category	Supplemental			GPS Latitude/Longitude	
				Start	End
Item	2017 Storm Damage			39.095592 °	39.095589 °
				-121.896103 °	-121.897400 °
DWR ID	DWR_NA0016_01_f_2017_125				
Comment Code					
Inspector Comment					
Levee Evaluation Comments					
Description:					
Site ID No:184					
Site Designation:SRWLD-02					
Repair Type: Seepage					
Rating:Critical					
Field Date:7/14/2017					
Notes: Currently taking core samples.

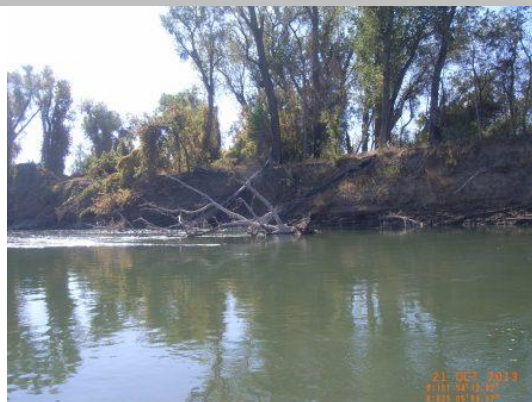
Photo 1 of 1 : FA_2018_NA0016_435_94_20181023_00237.jpg

LM Start	35.23	Rating **	A/W	Issue No.	94
LM End	35.33	Issue Type +	Ma	Location *	WS
Category	Supplemental			GPS Latitude/Longitude	
				Start	End
Item	2017 USACE Erosion Survey, DRAFT			39.099482 °	39.100836 °
				-121.903430 °	-121.904320 °
DWR ID	DWR_NA0016_01_f_2018_94				
Comment Code					
Inspector Comment					
2017 Site ID: SAC 127.9 R					
Status: Eroding					
2017 Field Notes: fresh erosion at lower slope.					
Site History: 1997 - Major scour off the downstream end of existing rock, creating a scour pocket where the levee starts diverging from the bankline. 2000 - Some minor erosion, 20 ft deep hole at downstream end. 2004 - Small amount of new erosion. 2010 - Bad transition off downstream end of rock revetment, some new erosion. 2012 - Site extended downstream, minor new erosion. 2013- Minor new erosion. 2016 - Fresh erosion at toe.

USACE 2013 Photo #1

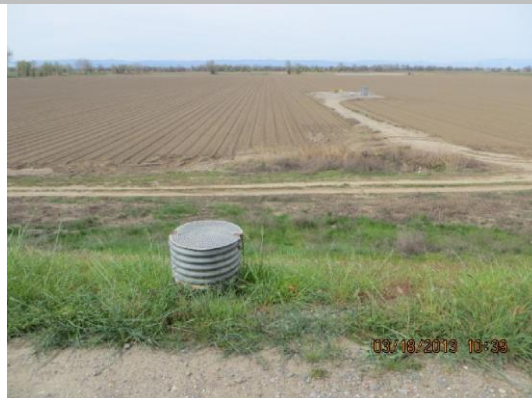
Photo 1 of 1 : UCIP_FA_2018_10424_17700.jpg

LM Start	35.56	Rating **	M	Issue No.	1590
LM End	35.56	Issue Type +	En	Location *	
Category	Supplemental			GPS Latitude/Longitude	
				Start	End
Item	DWR UCIP Field Study			39.103533 °	39.103533 °
				-121.906814 °	-121.906814 °
DWR ID	20273				
Comment Code					
Inspector Comment					
FS_ID:10424 DS_ID:20273 EP_NO: 9364A Repair Type: Non-Urgent Crossing Status: Found UCIP Comments: Need to verify type of abandonment. FIELD_STRUCT_DESC: 3 of 4: 18-inch steel irrigation pipe through the levee, 16 feet below the crown. Metal cutoff wall. Gate valve on the waterside (WS) bank. Siphon breaker in a 24-inch corrugated metal riser unit on the landside (LS) shoulder. (Automatic Board Order (ABO) issued as Permit No. 9364-A, 1974 - Alice Steidlmayer). [Additional Reference(s): DWR Levee Log, 2006. USACE Sacramento O&M Manual 131, May 1960 (HLM 36.04)]. FS Date: 3/18/2013

Siphon breaker in 24-inch CMP riser on LS shoulder.

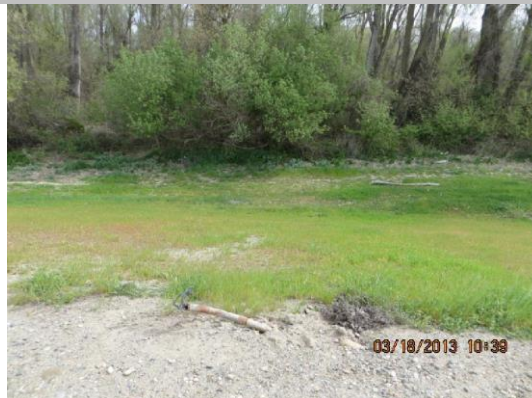
Photo 1 of 2 : UCIP_FA_2018_10425_17702.jpg

LM Start	35.56	Rating **	M	Issue No.	1591
LM End	35.56	Issue Type +	En	Location *	
Category	Supplemental			GPS Latitude/Longitude	
				Start	End
Item	DWR UCIP Field Study			39.103533 °	39.103533 °
				-121.906814 °	-121.906814 °
DWR ID	20398				
Comment Code					
Inspector Comment					
FS_ID:10425 DS_ID:20398 EP_NO: 9364 Repair Type: Non-Urgent Crossing Status: Found UCIP Comments: Remove abandoned pipe from levee. FIELD_STRUCT_DESC: *ABANDONED* 4 of 4: 1.25-inch electrical conduit of an unknown material through the levee, 3 feet below the crown. (Automatic Board Order (ABO) issued as Permit No. 9364-A, 1974 - Alice Steidlmaier). FS Date: 3/18/2013

Electrical conduit on WS shoulder.

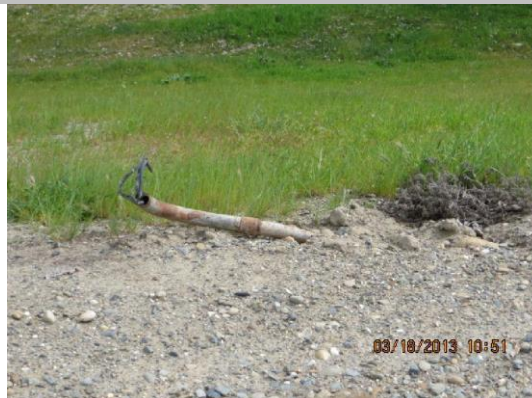
Photo 2 of 2 : UCIP_FA_2018_10425_17701.jpg

LM Start	35.56	Rating **	M	Issue No.	1591 (cont)	
LM End	35.56	Issue Type +	En	Location *		
Category	Supplemental			GPS Latitude/Longitude		
				Start	End	
Item	DWR UCIP Field Study			39.103533 °	39.103533 °	
				-121.906814 °	-121.906814 °	
DWR ID	20398					
Comment Code						
Inspector Comment						
FS_ID:10425 DS_ID:20398 EP_NO: 9364 Repair Type: Non-Urgent Crossing Status: Found UCIP Comments: Remove abandoned pipe from levee. FIELD_STRUCT_DESC: *ABANDONED* 4 of 4: 1.25-inch electrical conduit of an unknown material through the levee, 3 feet below the crown. (Automatic Board Order (ABO) issued as Permit No. 9364-A, 1974 - Alice Steidlmayer). FS Date: 3/18/2013

Electrical conduit on WS shoulder.

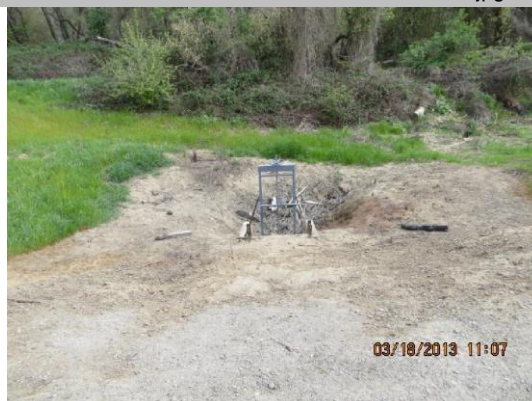
Photo 1 of 3 : UCIP_FA_2018_10426_17705.jpg

Comment Code						
Inspector Comment						
FS_ID:10426 DS_ID:20345 EP_NO: 9374 Repair Type: Non-Urgent Crossing Status: Found UCIP Comments: Verify if pipe is abandoned with landowner and remove or abandon properly if necessary. FIELD_STRUCT_DESC: *ABANDONED* 3 of 3: 24-inch concrete encased steel drainage pipe through the levee, 17 feet below the crown. Slide gate on concrete headwall on waterside (WS) end. Walkway to control gate and gate valve on landside (LS) end. (24-inch pipe [HLM 36.61] authorized under Automatic Board Order (ABO) issued as Permit No. 9374, 1974 - Richard H. Moore). [Additional Reference(s): USACE Sacramento O&M Manual 131, May 1960 (HLM 36.61)]. FS Date: 3/18/2013

Slide gate on WS toe.

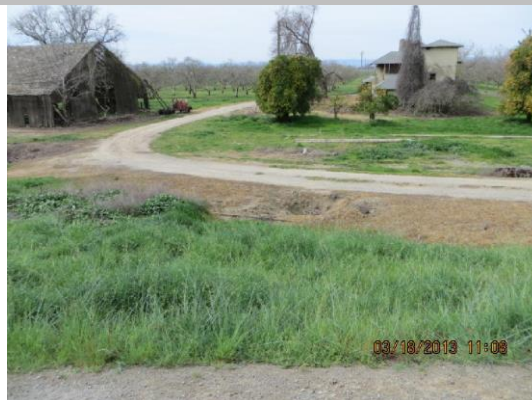
Photo 2 of 3 : UCIP_FA_2018_10426_17704.jpg

Headwall and gate valve on LS toe buried but partially exposed.

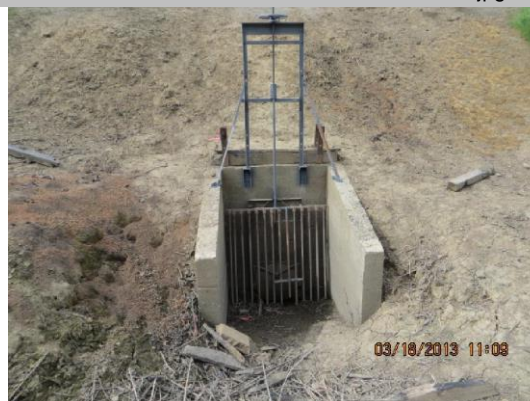
Photo 3 of 3 : UCIP_FA_2018_10426_17703.jpg

Item	DWR UCIP LMA Responsibility			39.111233 °		39.111233 °
				-121.911450 °		-121.911450 °
DWR ID	20345					
Comment Code						
Inspector Comment						
FS_ID:10426 DS_ID:20345 EP_NO: 9374 Repair Type: Non-Urgent Crossing Status: Found UCIP Comments: Verify if pipe is abandoned with landowner and remove or abandon properly if necessary. FIELD_STRUCT_DESC: *ABANDONED* 3 of 3: 24-inch concrete encased steel drainage pipe through the levee, 17 feet below the crown. Slide gate on concrete headwall on waterside (WS) end. Walkway to control gate and gate valve on landside (LS) end. (24-inch pipe [HLM 36.61] authorized under Automatic Board Order (ABO) issued as Permit No. 9374, 1974 - Richard H. Moore). [Additional Reference(s): USACE Sacramento O&M Manual 131, May 1960 (HLM 36.61)]. FS Date: 3/18/2013

Outlet/inlet on WS toe.

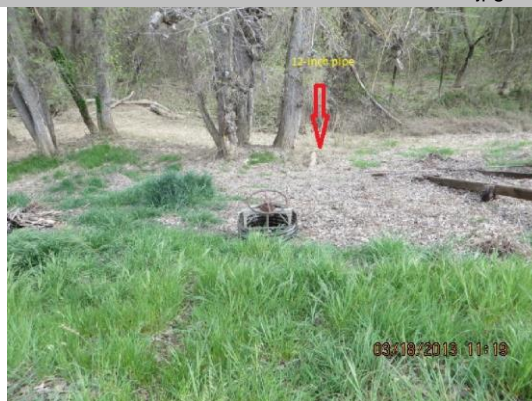
Photo 1 of 3 : UCIP_FA_2018_10444_17725.jpg

Comment Code					
Inspector Comment					
FS_ID:10444 DS_ID:20274 EP_NO: 9374 Repair Type: Non-Urgent Crossing Status: Found UCIP Comments: Pipe should be abandoned properly. FIELD_STRUCT_DESC: 4 of 4: 24-inch corrugated metal irrigation pipe through the levee, 15.5 feet below the crown. Two corrugated metal cutoff walls. Slide gate in a 36-inch corrugated metal riser unit on the waterside (WS) slope. Pump house with no connection on the WS bank. 12-inch steel pipe with steel plate over end at WS toe (likely pump connection point). 6-foot diameter concrete riser on landside (LS) toe. Skid rails mounted on wood piling on the WS slope. Department of Water Resources B.M. SR 47 on top of concrete anchor post on the WS shoulder. Power pole and meter box on the WS shoulder. Switch panel in metal house on the WS slope. Concrete standpipe on the LS. Overhead power line crosses the levee to service pole. (Automatic Board Order (ABO) issued as Permit No. 9374, 1974 - Richard H. Moore). [Additional Reference(s): DWR Levee Log, 2006]. FS Date: 3/18/2013 7:51:00 AM

36-inch CMP riser with slide gate on WS slope with 12-inch pipe at Toe.

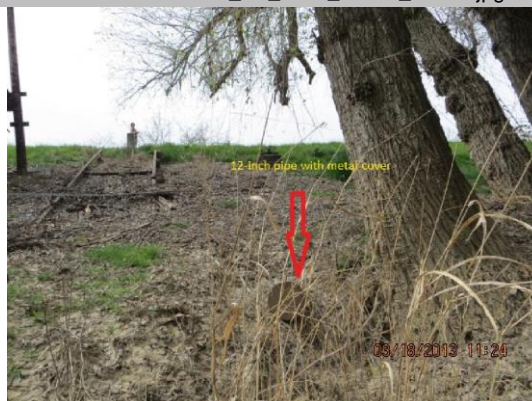
Photo 2 of 3 : UCIP_FA_2018_10444_17724.jpg

Wooden ramp and 2-inch pump connection at WS toe.

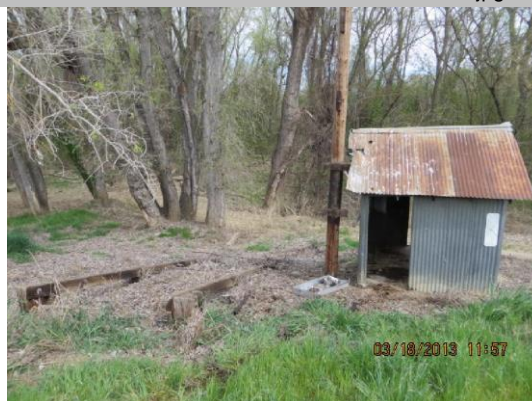
Photo 3 of 3 : UCIP_FA_2018_10444_17723.jpg

Item	DWR UCIP Field Study			39.112377 °	39.112377 °	
				-121.912286 °	-121.912286 °	
DWR ID	20274					
Comment Code						
Inspector Comment						
FS_ID:10444 DS_ID:20274 EP_NO: 9374 Repair Type: Non-Urgent Crossing Status: Found UCIP Comments: Pipe should be abandoned properly. FIELD_STRUCT_DESC: 4 of 4: 24-inch corrugated metal irrigation pipe through the levee, 15.5 feet below the crown. Two corrugated metal cutoff walls. Slide gate in a 36-inch corrugated metal riser unit on the waterside (WS) slope. Pump house with no connection on the WS bank. 12-inch steel pipe with steel plate over end at WS toe (likely pump connection point). 6-foot diameter concrete riser on landside (LS) toe. Skid rails mounted on wood piling on the WS slope. Department of Water Resources B.M. SR 47 on top of concrete anchor post on the WS shoulder. Power pole and meter box on the WS shoulder. Switch panel in metal house on the WS slope. Concrete standpipe on the LS. Overhead power line crosses the levee to service pole. (Automatic Board Order (ABO) issued as Permit No. 9374, 1974 - Richard H. Moore). [Additional Reference(s): DWR Levee Log, 2006]. FS Date: 3/18/2013 7:51:00 AM

Pump house, JP, and wooden ramp on WS slope.

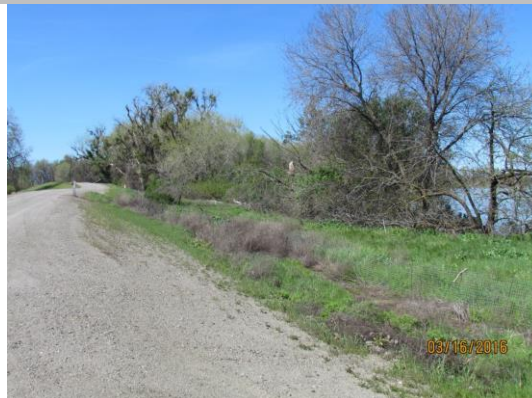
Photo 1 of 2 : FA_2018_NA0016_435_33_20180904_00013.jpg

LM Start	37.07	Rating **	A/W	Issue No.	33
LM End	37.15	Issue Type +	Ob	Location *	WS
Category	Earthen Levee			GPS Latitude/Longitude	
				Start	End
Item	Vegetation			39.121003°	39.121547°
				-121.919888°	-121.921278°
DWR ID	DWR_NA0016_01_s_2012_33				
Comment Code					
V8 : Environmental Requirements.					
Inspector Comment					
Revegetation site is fenced off.

View of the revegetation site on the waterward berm of the levee looking upstream. Spring 2016.

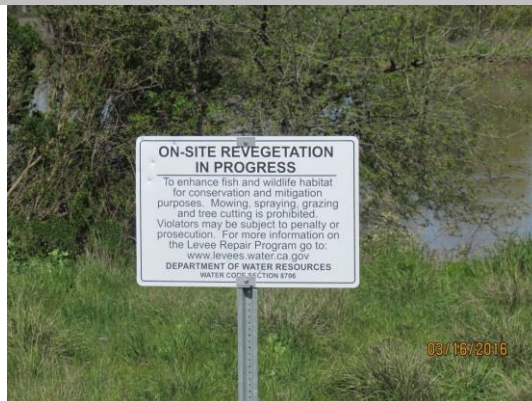
Photo 2 of 2 : FA_2018_NA0016_435_33_20180904_00014.jpg

Sign stating the revegetation site. Spring 2016.

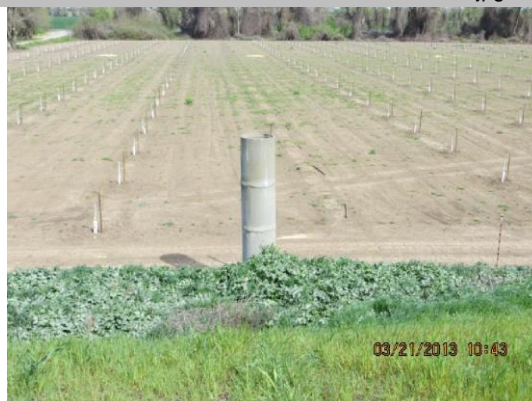
Photo 1 of 3 : UCIP_FA_2018_10528_17854.jpg

Comment Code						
Inspector Comment						
FS_ID:10528 DS_ID:20282 EP_NO: 9352 Repair Type: Non-Urgent Crossing Status: Found UCIP Comments: Pipe appears to have been removed from levee section. Need to verify pipe abandonment. FIELD_STRUCT_DESC: 12-inch steel irrigation pipe through the levee, 5 feet below the crown. Switch house on the waterside (WS) shoulder. Pump and gate valve on the WS bank. Concrete discharge standpipe on the landside (LS). (For a 14-inch pipe, Permit No. 635, 1935 - Henry F. Schmidt). (Automatic Board Order (ABO) issued as Permit No. 9351, 1974 - W. A. Gerrans). [Additional Reference(s): DWR Levee Log, 2006. USACE Sacramento O&M Manual 131, May 1960 (HLM 40.43)]. FS Date: 3/21/2013

Concrete standpipe at LS toe.

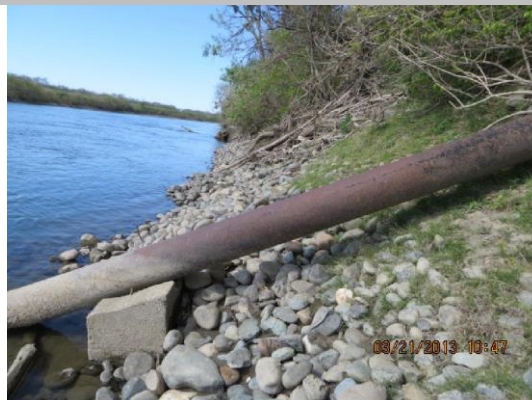
Photo 2 of 3 : UCIP_FA_2018_10528_17853.jpg

Pipe visible at WS toe.

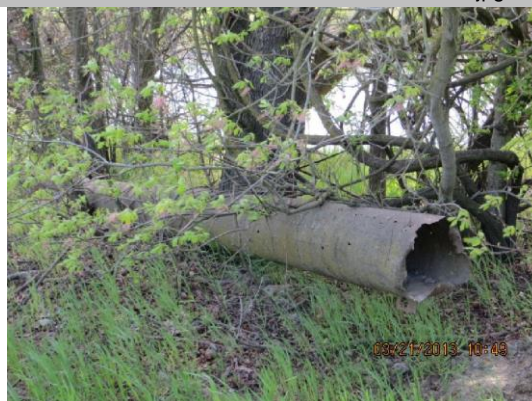
Photo 3 of 3 : UCIP_FA_2018_10528_17852.jpg

Item	DWR UCIP Field Study			39.143387 °		39.143387 °
				-121.927196 °		-121.927196 °
DWR ID	20282					
Comment Code						
Inspector Comment						
FS_ID:10528 DS_ID:20282 EP_NO: 9352 Repair Type: Non-Urgent Crossing Status: Found UCIP Comments: Pipe appears to have been removed from levee section. Need to verify pipe abandonment. FIELD_STRUCT_DESC: 12-inch steel irrigation pipe through the levee, 5 feet below the crown. Switch house on the waterside (WS) shoulder. Pump and gate valve on the WS bank. Concrete discharge standpipe on the landside (LS). (For a 14-inch pipe, Permit No. 635, 1935 - Henry F. Schmidt). (Automatic Board Order (ABO) issued as Permit No. 9351, 1974 - W. A. Gerrans). [Additional Reference(s): DWR Levee Log, 2006. USACE Sacramento O&M Manual 131, May 1960 (HLM 40.43)]. FS Date: 3/21/2013

12-inch pipe debris on WS berm.

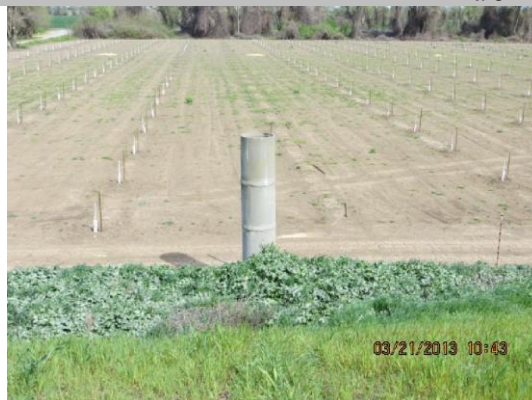
Photo 1 of 2 : UCIP_FA_2018_11343_18741.jpg

LM Start	39.93	Rating **	M	Issue No.	1595
LM End	39.93	Issue Type +	En	Location *	
Category	Supplemental			GPS Latitude/Longitude	
				Start	End
Item	DWR UCIP Field Study			39.143387°	39.143387°
				-121.927196°	-121.927196°
DWR ID	22966				
Comment Code					
Inspector Comment					
FS_ID:11343 DS_ID:22966 EP_NO: 9352 Repair Type: Non-Urgent Crossing Status: Found UCIP Comments: Pipe should be removed. FIELD_STRUCT_DESC: 1.5-inch galvanized steel electrical conduit through the levee, at an unknown depth. Visible on the waterside (WS) slope. (Permit No. 635, 1935 - Henry F. Schmidt). FS Date: 3/21/2013

Electrical conduit approximately perpendicular to concrete riser on LS toe.

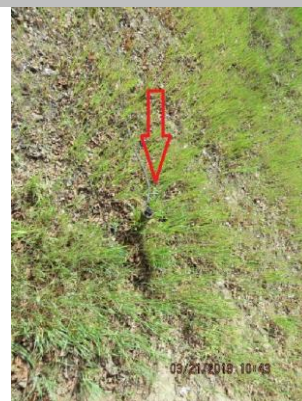
Photo 2 of 2 : UCIP_FA_2018_11343_18740.jpg

LM Start	39.93	Rating **	M	Issue No.	1595 (cont)							
LM End	39.93	Issue Type +	En	Location *								
Category	Supplemental		GPS Latitude/Longitude									
			Start	End								
Item	DWR UCIP Field Study		39.143387°	39.143387°								
			-121.927196°	-121.927196°								
DWR ID	22966											
Comment Code												
Inspector Comment												
FS_ID:11343 DS_ID:22966 EP_NO: 9352 Repair Type: Non-Urgent Crossing Status: Found UCIP Comments: Pipe should be removed. FIELD_STRUCT_DESC: 1.5-inch galvanized steel electrical conduit through the levee, at an unknown depth. Visible on the waterside (WS) slope. (Permit No. 635, 1935 - Henry F. Schmidt). FS Date: 3/21/2013

1.5-inch electrical conduit on WS slope.

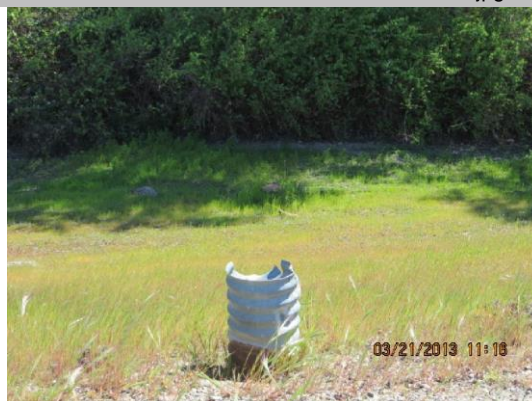
Photo 1 of 3 : UCIP_FA_2018_10527_17850.jpg

LM Start	40.44	Rating **	M	Issue No.	1596
LM End	40.44	Issue Type +	En	Location *	
Category	Supplemental			GPS Latitude/Longitude	
				Start	End
Item	DWR UCIP Field Study			39.143838 °	39.143838 °
				-121.919338 °	-121.919338 °
DWR ID	20285				
Comment Code					
Inspector Comment					
FS_ID:10527 DS_ID:20285 EP_NO: 12799 Repair Type: Non-Urgent Crossing Status: Found UCIP Comments: Pipe appears abandoned. Need to verify type of abandonment FIELD_STRUCT_DESC: 18-inch steel irrigation pipe through the levee, 6.5 feet below the crown. 30-inch corrugated metal standpipe on landside (LS) toe. Pump on the waterside (WS) toe. Vent inside a 12-inch corrugated metal riser unit on the WS shoulder. (Permit No. 12799, 1979 - Bruce Myers). [Additional Reference(s): DWR Levee Log, 2006]. FS Date: 3/21/2013

Vent in 12-inch CMP riser on WS shoulder.

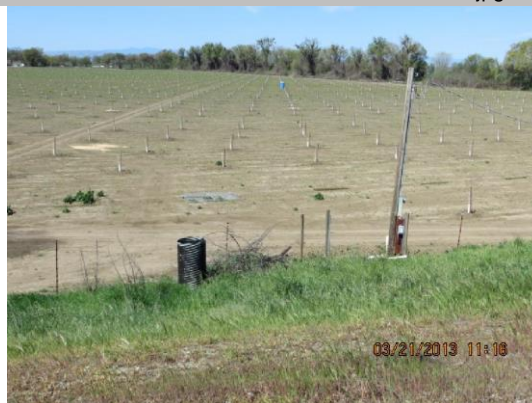
Photo 2 of 3 : UCIP_FA_2018_10527_17849.jpg

30-inch CMP riser with slide gate at LS toe.

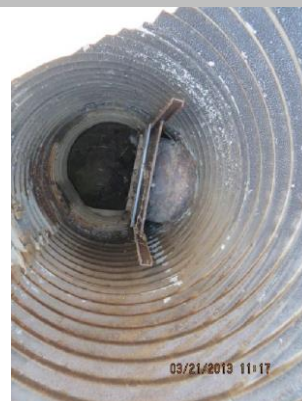
Photo 3 of 3 : UCIP_FA_2018_10527_17848.jpg

LM Start	40.44	Rating **	M	Issue No.	1596 (cont)	
LM End	40.44	Issue Type +	En	Location *		
Category	Supplemental			GPS Latitude/Longitude		
				Start		End
Item	DWR UCIP Field Study			39.143838 °		39.143838 °
				-121.919338 °		-121.919338 °
DWR ID	20285					
Comment Code						
Inspector Comment						
FS_ID:10527 DS_ID:20285 EP_NO: 12799 Repair Type: Non-Urgent Crossing Status: Found UCIP Comments: Pipe appears abandoned. Need to verify type of abandonment FIELD_STRUCT_DESC: 18-inch steel irrigation pipe through the levee, 6.5 feet below the crown. 30-inch corrugated metal standpipe on landside (LS) toe. Pump on the waterside (WS) toe. Vent inside a 12-inch corrugated metal riser unit on the WS shoulder. (Permit No. 12799, 1979 - Bruce Myers). [Additional Reference(s): DWR Levee Log, 2006]. FS Date: 3/21/2013

Slide gate in CMP riser on LS toe.

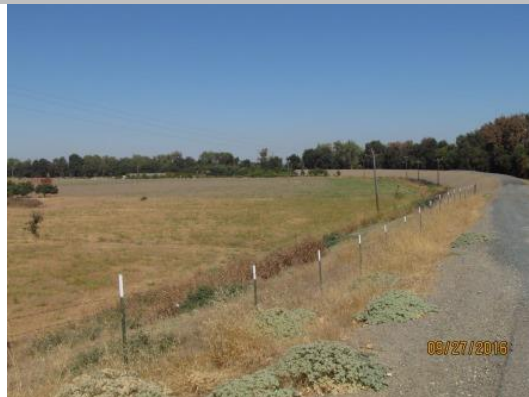
Photo 1 of 1 : FA_2018_NA0016_435_102_20180904_00025.jpg

LM Start	40.64	Rating **	M	Issue No.	102
LM End	40.72	Issue Type +	En	Location *	LS
Category	Earthen Levee			GPS Latitude/Longitude	
				Start	End
Item	Encroachments			39.146602 °	39.147582 °
				-121.918897 °	-121.918429 °
DWR ID	DWR_NA0016_01_s_2015_102				
Comment Code					
FE : Fence					
Inspector Comment

View of owner's fence on landside. Fall 2016 inspection.

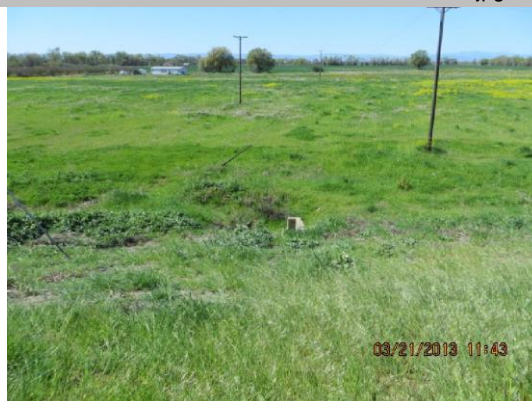
Photo 1 of 3 : UCIP_FA_2018_10533_17865.jpg

Comment Code					
Inspector Comment					
FS_ID:10533 DS_ID:20287 EP_NO: 9351 Repair Type: Non-Urgent Crossing Status: Found UCIP Comments: Appears abandoned. Should be abandoned properly. FIELD_STRUCT_DESC: 30-inch corrugated metal irrigation pipe through the levee, 17.5 feet below the crown. Slide gate on the waterside (WS) end. Discharges into a concrete box at the landside (LS) toe. Small pump discharges into a sump area in front of slide gate at WS toe. (Automatic Board Order (ABO) issued as Permit No. 9351, 1974 - W. A. Gerrans). [Additional Reference(s): DWR Levee Log, 2006. USACE Sacramento O&M Manual 131, May 1960 (HLM 41.39)]. FS Date: 3/21/2013

Demolished concrete distribution box at LS toe.

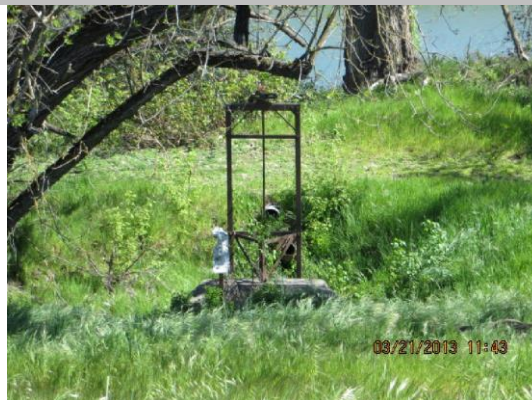
Photo 2 of 3 : UCIP_FA_2018_10533_17864.jpg

Slide gate at WS toe.

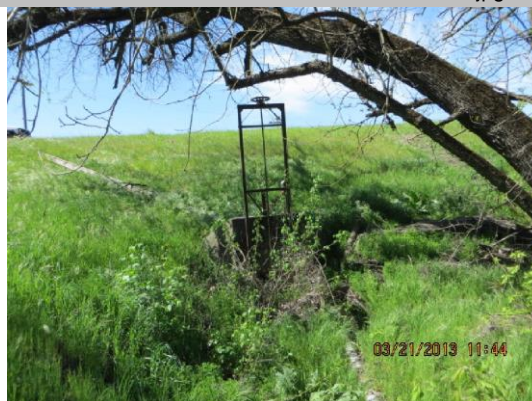
Photo 3 of 3 : UCIP_FA_2018_10533_17863.jpg

Item	DWR UCIP Field Study			39.150054 °	39.150054 °	
				-121.918717 °	-121.918717 °	
DWR ID	20287					
Comment Code						
Inspector Comment						
FS_ID:10533 DS_ID:20287 EP_NO: 9351 Repair Type: Non-Urgent Crossing Status: Found UCIP Comments: Appears abandoned. Should be abandoned properly. FIELD_STRUCT_DESC: 30-inch corrugated metal irrigation pipe through the levee, 17.5 feet below the crown. Slide gate on the waterside (WS) end. Discharges into a concrete box at the landside (LS) toe. Small pump discharges into a sump area in front of slide gate at WS toe. (Automatic Board Order (ABO) issued as Permit No. 9351, 1974 - W. A. Gerrans). [Additional Reference(s): DWR Levee Log, 2006. USACE Sacramento O&M Manual 131, May 1960 (HLM 41.39)]. FS Date: 3/21/2013

Slide gate at WS toe.

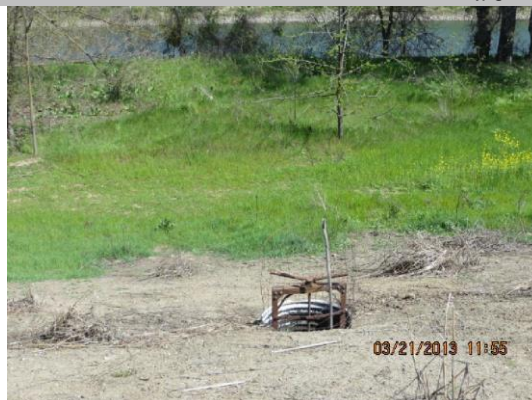
Photo 1 of 3 : UCIP_FA_2018_10535_17877.jpg

Comment Code					
Inspector Comment					
FS_ID:10535					
DS_ID:20288					
EP_NO: N/A					
Repair Type: No Action Needed					
Crossing Status: Found					
UCIP Comments:					
FIELD_STRUCT_DESC: 24-inch drainage pipe of an unknown material through the levee, 19 feet below the crown. 6-foot diameter corrugated metal standpipe on the landside (LS) toe. Pump and 24-inch pipe on the LS. Slide gate in corrugated metal riser unit on waterside (WS) slope. Concrete block wall at WS toe for discharge line. (Modified under Permit No. 8587, 1973 - Anthony E. Steidlmyer). [Additional Reference(s): DWR Levee Log, 2006. USACE Sacramento O&M Manual 131, May 1960 (HLM 41.56)].					
FS Date: 3/21/2013

Slide gate in CMP riser on WS slope.

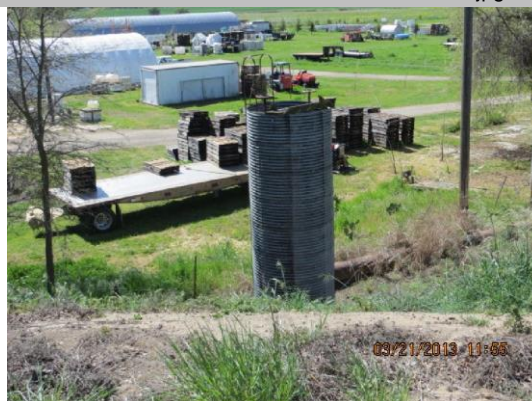
Photo 2 of 3 : UCIP_FA_2018_10535_17876.jpg

LM Start	41.08	Rating **	A/W	Issue No.	1598 (cont)
LM End	41.08	Issue Type +	Ma	Location *

6-foot diameter CMP riser with slide gates on LS toe.

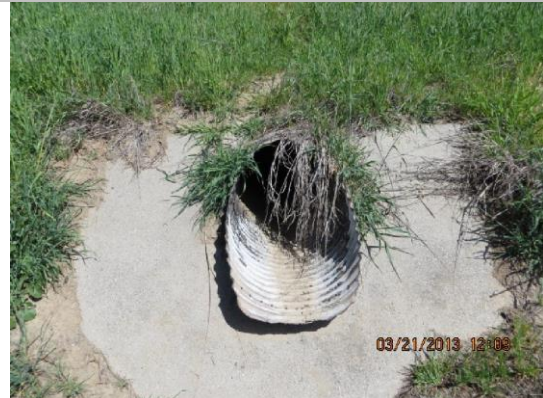
Photo 1 of 3 : UCIP_FA_2018_10536_17883.jpg

LM Start	41.86	Rating **	M	Issue No.	1599	
LM End	41.86	Issue Type +	En	Location *		
Category	Supplemental			GPS Latitude/Longitude		
				Start	End	
Item	DWR UCIP Field Study			39.158648 °	39.158648 °	
				-121.932429 °	-121.932429 °	
DWR ID	20289					
Comment Code						
Inspector Comment						
FS_ID:10536 DS_ID:20289 EP_NO: 9341 Repair Type: Non-Urgent Crossing Status: Found UCIP Comments: Appears abandoned. Needs to be abandoned properly. FIELD_STRUCT_DESC: 30-inch irrigation pipe of an unknown material through the levee, 19.5 feet below the crown. Slide gate in a 36-inch corrugated metal riser unit on the waterside (WS) slope. (Automatic Board Order (ABO) issued as Permit No. 9341, 1974 - F. J. Steidlmayer). [Additional Reference(s): DWR Levee Log, 2006. USACE Sacramento O&M Manual 131, May 1960 (HLM 42.37)]. FS Date: 3/21/2013

30-inch CMP at outlet on LS toe.

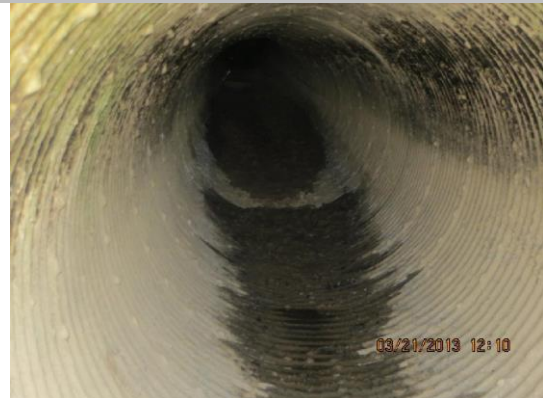
Photo 2 of 3 : UCIP_FA_2018_10536_17882.jpg

View from LS toe of CMP pipe.

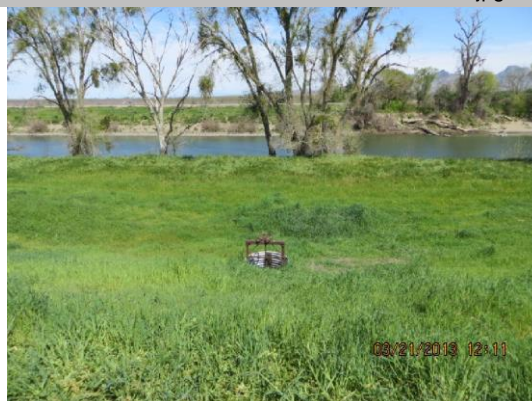
Photo 3 of 3 : UCIP_FA_2018_10536_17881.jpg

LM Start	41.86	Rating **	M	Issue No.	1599 (cont)	
LM End	41.86	Issue Type +	En	Location *		
Category	Supplemental			GPS Latitude/Longitude		
				Start		End
Item	DWR UCIP Field Study			39.158648 °	39.158648 °	
				-121.932429 °	-121.932429 °	
DWR ID	20289					
Comment Code						
Inspector Comment						
FS_ID:10536						
DS_ID:20289						
EP_NO: 9341						
Repair Type: Non-Urgent						
Crossing Status: Found						
UCIP Comments: Appears abandoned. Needs to be abandoned properly.						
FIELD_STRUCT_DESC: 30-inch irrigation pipe of an unknown material through the levee, 19.5 feet below the crown. Slide gate in a 36-inch corrugated metal riser unit on the waterside (WS) slope. (Automatic Board Order (ABO) issued as Permit No. 9341, 1974 - F. J. Steidlmayer). [Additional Reference(s): DWR Levee Log, 2006. USACE Sacramento O&M Manual 131, May 1960 (HLM 42.37)].						
FS Date: 3/21/2013

Slide gate in CMP riser on WS toe.

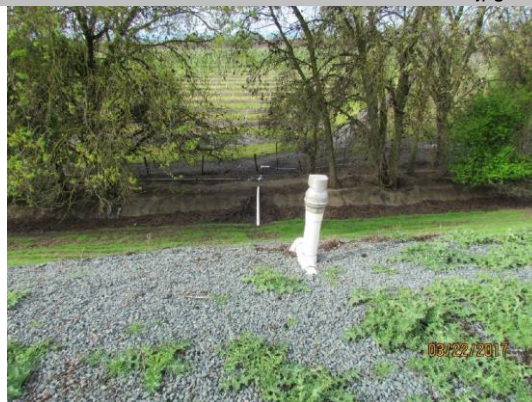
Photo 1 of 3 : UCIP_FA_2018_52625_76995.jpg

LM Start	43.05	Rating **	M	Issue No.	1600
LM End	43.05	Issue Type +	En	Location *	
Category	Supplemental			GPS Latitude/Longitude	
				Start	End
Item	DWR UCIP Field Study			39.174301 °	39.174301 °
				-121.940811 °	-121.940811 °
DWR ID	25485

Comment Code					
Inspector Comment					
FS_ID:52625					
DS_ID:25485					
EP_NO: N/A					
Repair Type: Non-Urgent					
Crossing Status: Found					
UCIP Comments: 05/23/2018 Contacted NA0016 superintendent about history and current status of the crossing. Confirmed that LMA has no additional information about this crossing that was put in before spring of 2017 (DWR UCIP-O.Yakimov)					
FIELD_STRUCT_DESC: 4-inch polyvinyl chloride (PVC) irrigation pipe through the levee, of an unknown depth below crown. Siphon breaker off landside (LS) shoulder. The pipe irrigates landscape on the waterside of the levee and is not permitted. Pipe found by DWR inspector Zach Jojola during Spring 2017 inspection.					
FS Date: 4/20/2017

LS view of siphon breaker off LS shoulder. Photo courtesy of Zach Jojola, DWR inspector.

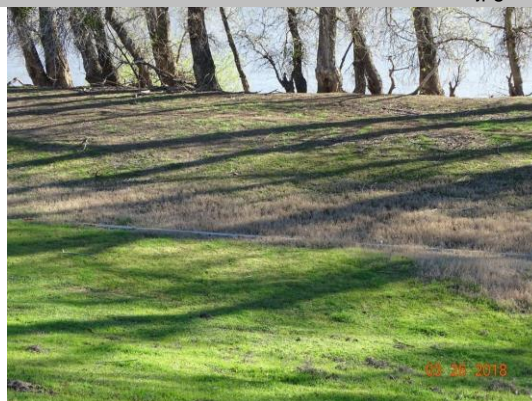
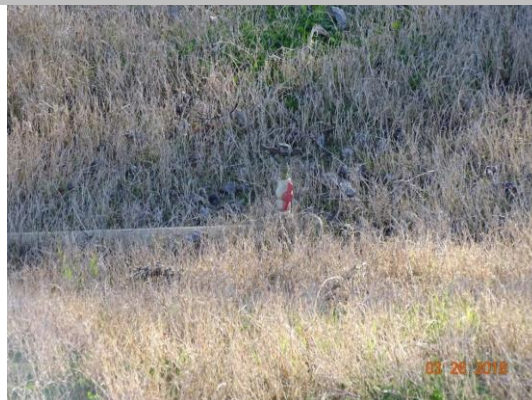
Sprinkler system on the waterside berm. Spring 2018 inspection, photo courtesy of Zach Jojola.

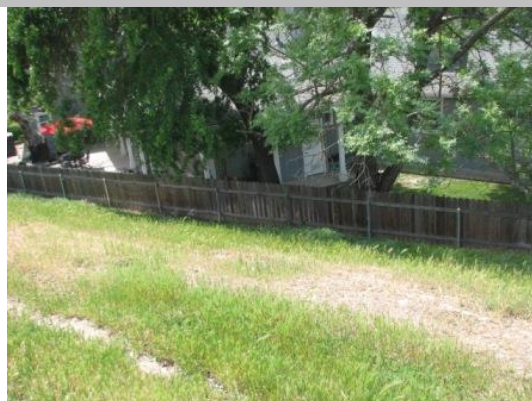
Photo 1 of 1 : FA_2018_NA0016_435_46_20180904_00016.jpg

LM Start	43.24	Rating **	M	Issue No.	46
LM End	43.24	Issue Type +	En	Location *	LS
Category	Earthen Levee			GPS Latitude/Longitude	
				Start	End
Item	Encroachments			39.176429 °	39.176429 °
				-121.942889 °	-121.942889 °
DWR ID	DWR_NA0016_01_s_2012_46				
Comment Code					
FE : Fence					
Inspector Comment

A solid fence along the toe of the levee. Photo taken spring 2012.

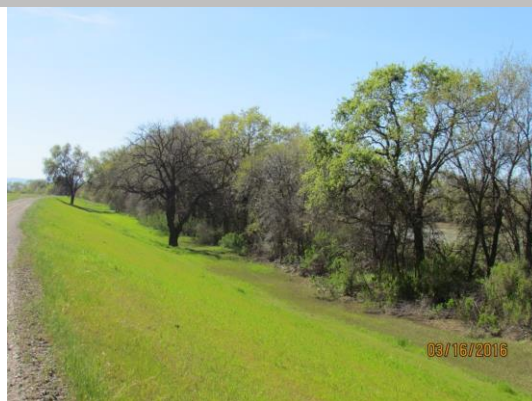
Photo 1 of 2 : FA_2018_NA0016_435_108_20180904_00026.jpg

LM Start	45.39	Rating **	A/W	Issue No.	108
LM End	45.90	Issue Type +	Ob	Location *	WS
Category	Earthen Levee			GPS Latitude/Longitude	
				Start	End
Item	Vegetation			39.192653 °	39.188518 °
				-121.952768 °	-121.960446 °
DWR ID	DWR_NA0016_01_s_2015_108				
Comment Code					
V8 : Environmental Requirements.					
Inspector Comment

View of the revegetation site on the waterward side of the levee looking upstream. Spring 2016.

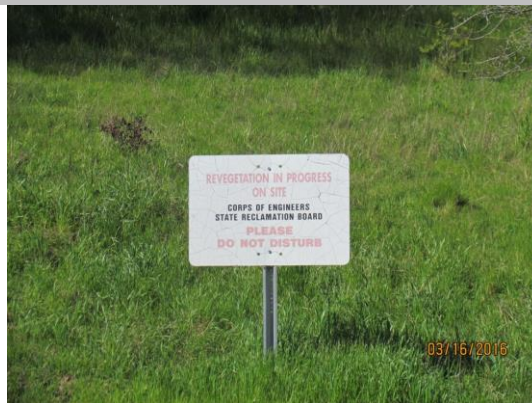
Photo 2 of 2 : FA_2018_NA0016_435_108_20180904_00027.jpg

Sign stating revegetation site. Spring 2016.
